Advisory Region Bridger Range Longitude -110.92W Latitude 45.82N **Avalanche Details:** <u>Shooting Cracks at Bridger Bowl</u> Bridger Range, 2019-10-31

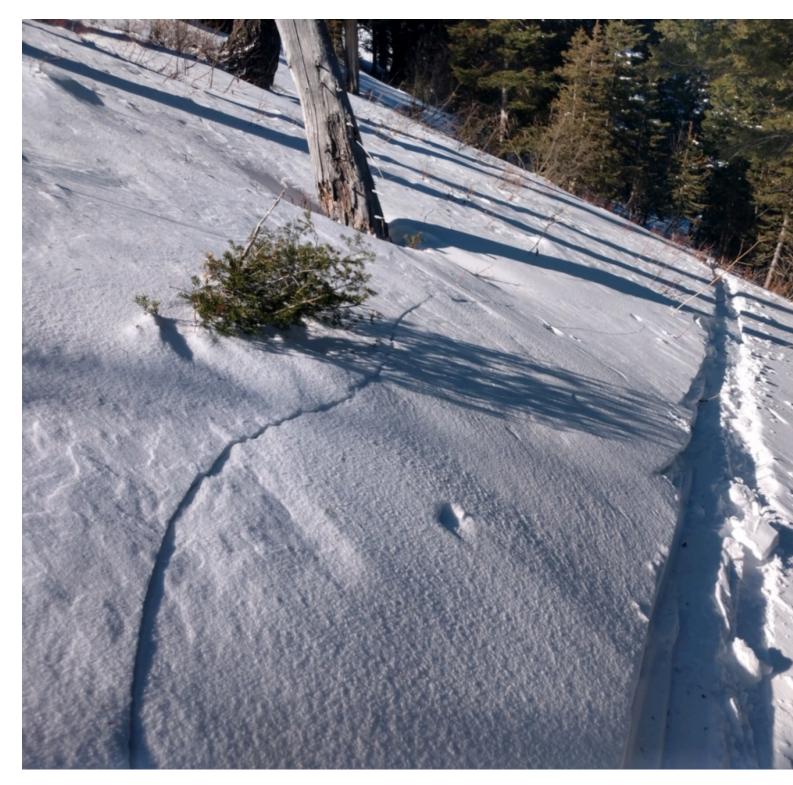
From an email, "...here's a pic from a north facing slope below Thunder Road, about midway up PK. We saw a few more shooting cracks in the flats below the top of PK, and the surface wind slab where this photo was taken was  $\sim 10$  cm."
