**Avalanche Details:** [Storm slabs at Bridger Bowl](#)

Bridger Range, 2022-11-09

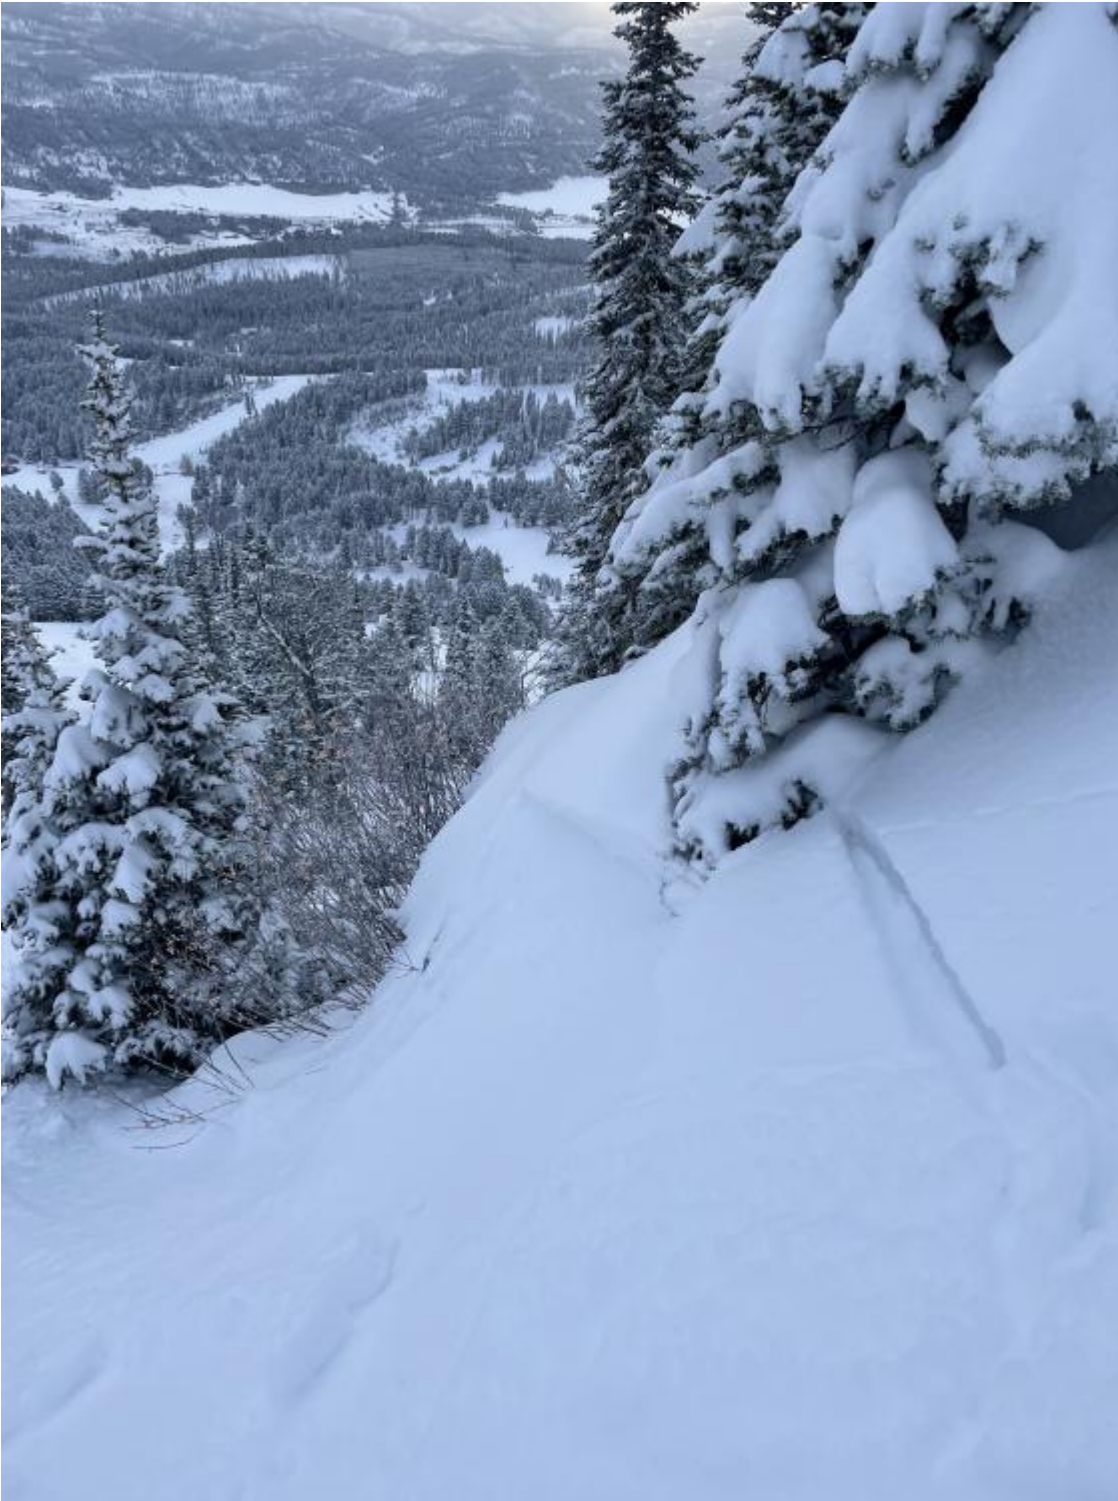
From obs: "Saw some cracking and propagation of a 6-8" storm slab on steeper terrain near the Bridger Lift. Gentle upslope winds seem to have compacted a slab near some terrain features, and I got a small propagation at the edge of the Sluice Box gully where the slope angle tipped up near 40." Photo: C. Avis
