Advisory Region Bridger Range

Bridger Range, 2011-02-15

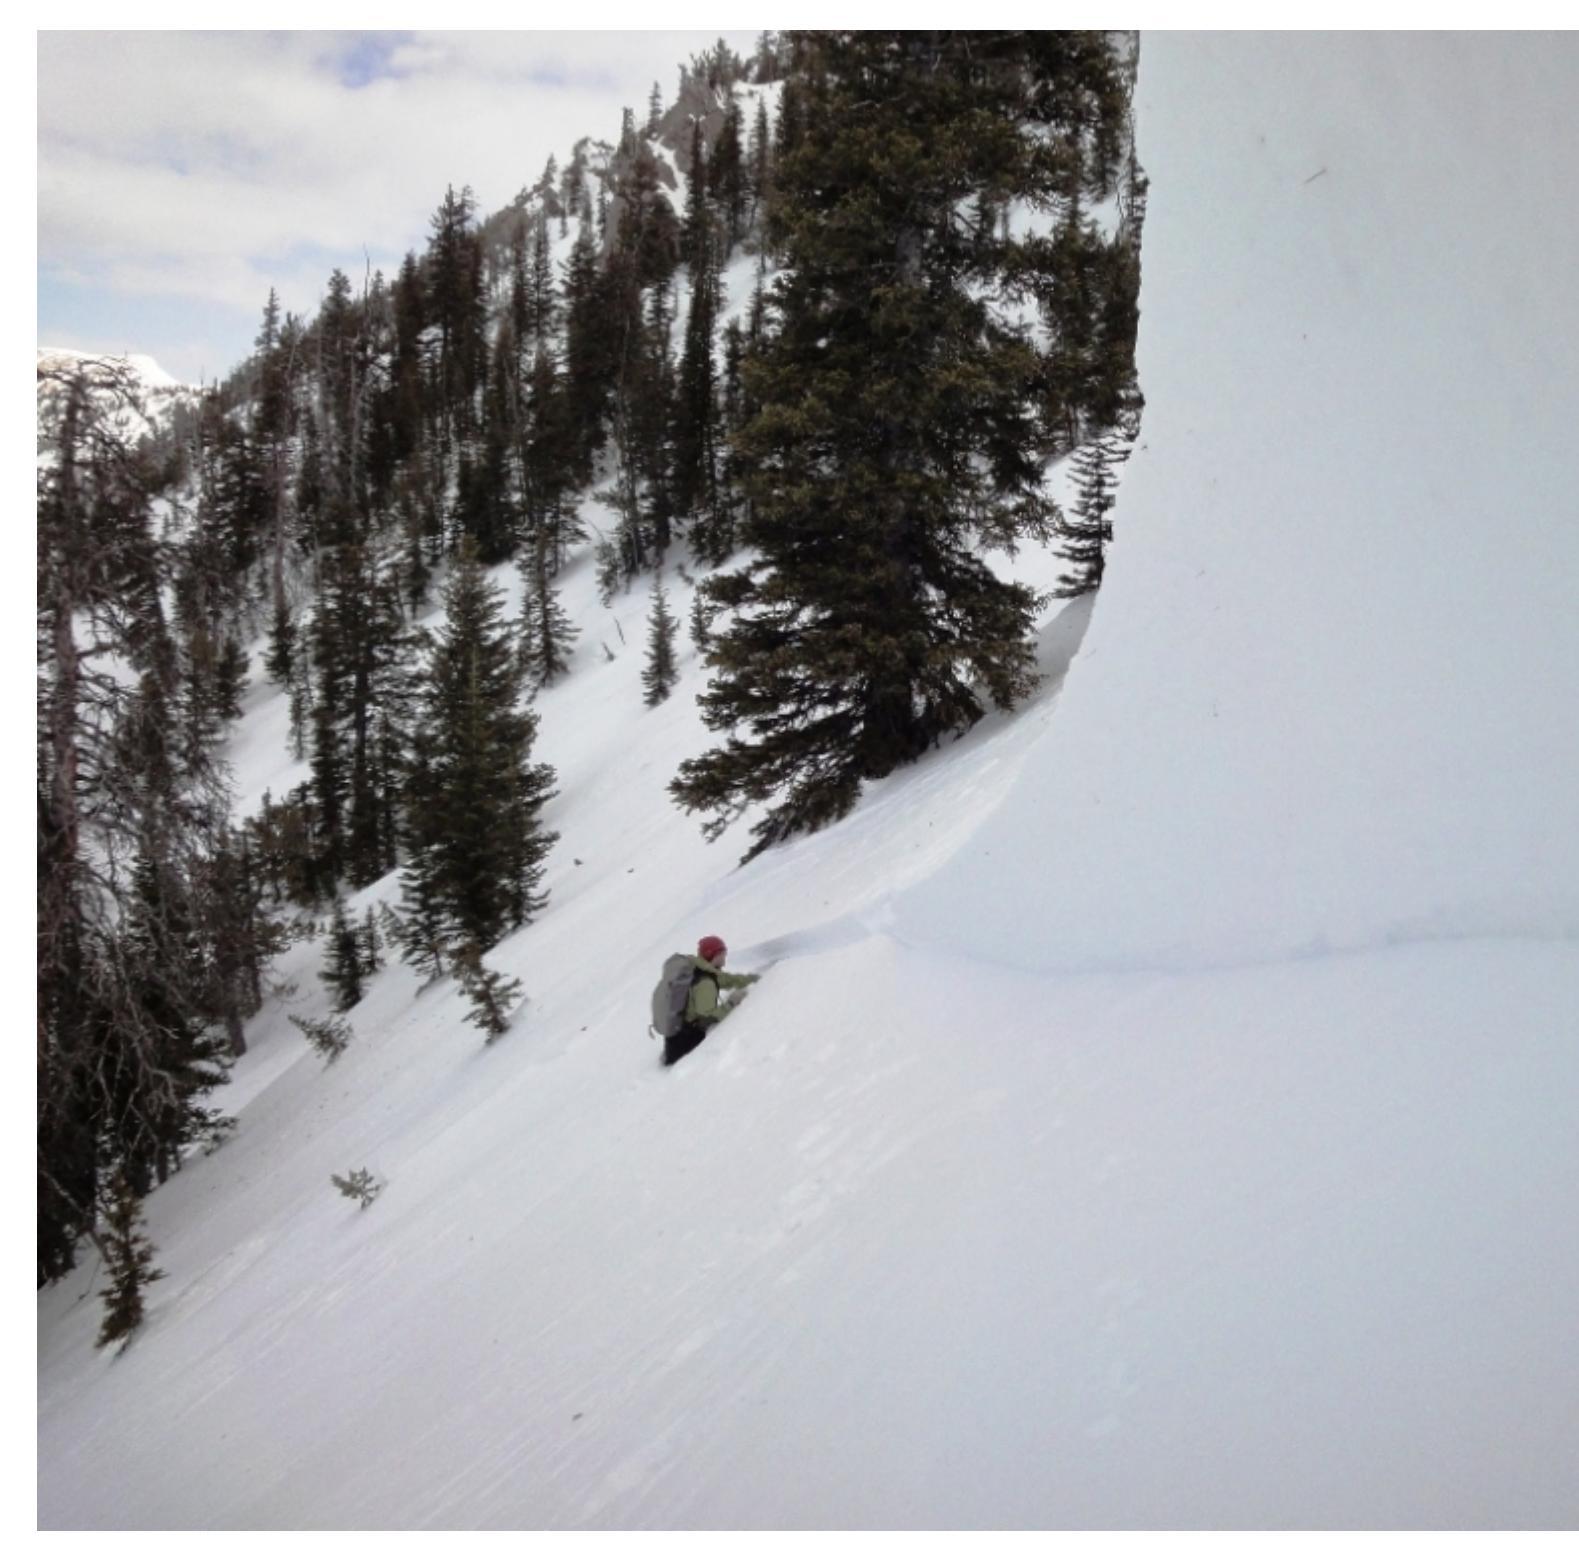
The crown was approximately 50 feet wide and broke 3 feet deep at its thickest spot. It tapered off to just a few inches deep at its northern end showing the extent of wind-loading in the gully. Photo: GNFAC
